# Effects of aging and use on Child Restraint Systems

A study carried out by the AESVI Alliance Research Commission  
February 2022

J.Forrellad , Jané Group , Jané Crash Test – J.J. Alba , Zaragoza, Spain University

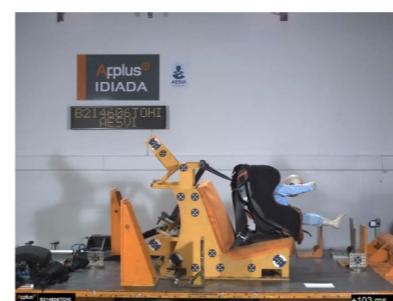
Picture 3: Máximo desplazamiento X / X maximum displacement

In 7 CRS (samples 01, 02, 03, 04, 05, 08 and 09), displacements above the limits set by the regulation were measured. In all of them, the X-axis displacement value was above the 550 mm limit set in the regulation.

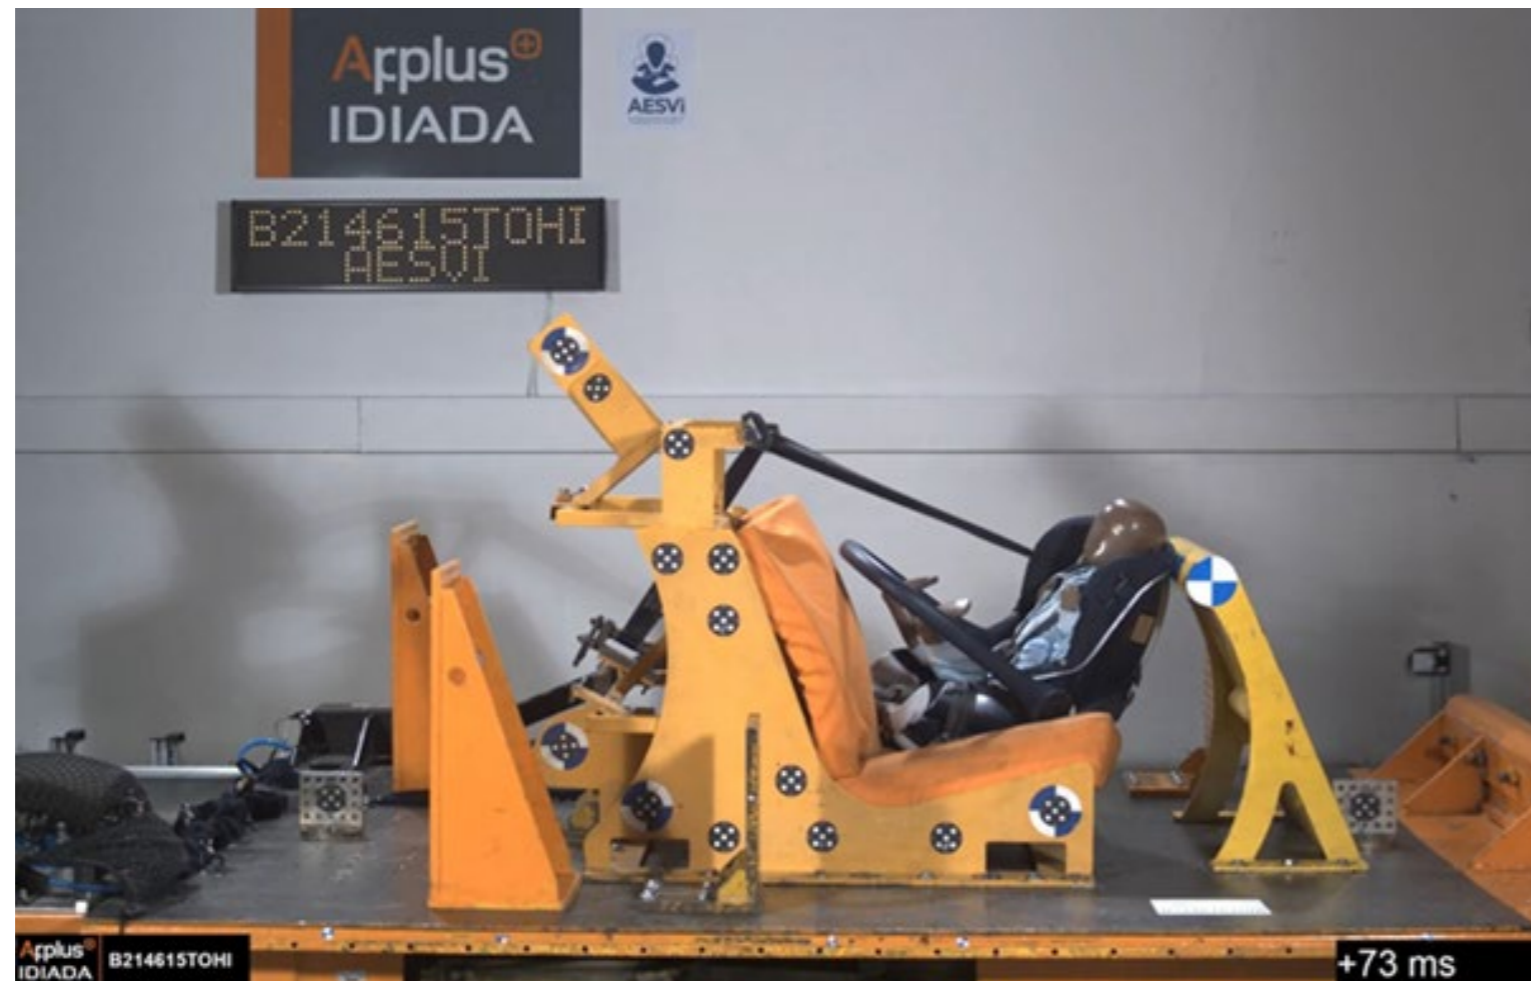
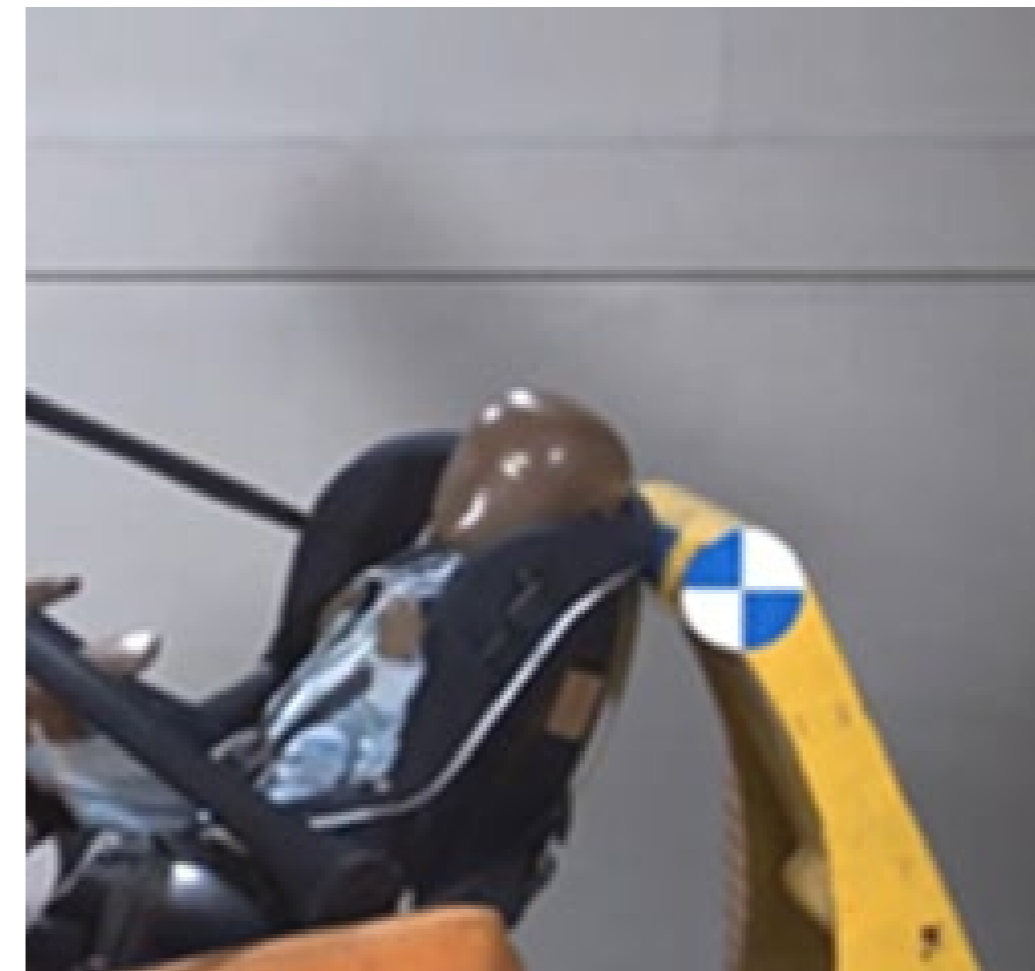
Only one of the CRS tested (sample 10) showed a correct behaviour in displacements and accelerations, within the tolerable limits, but this test.

According to the provisions of UN Regulation R4404 "In this configuration, an additional test is necessary without the 100mm diameter bar, in order to verify that the result is within the limits of the Regulation."
