# Effects of aging and use on Child Restraint Systems

A study carried out by the AESVI Alliance Research Commission  
February 2022

J.Forrellad , Jané Group , Jané Crash Test – J.J. Alba , Zaragoza, Spain University

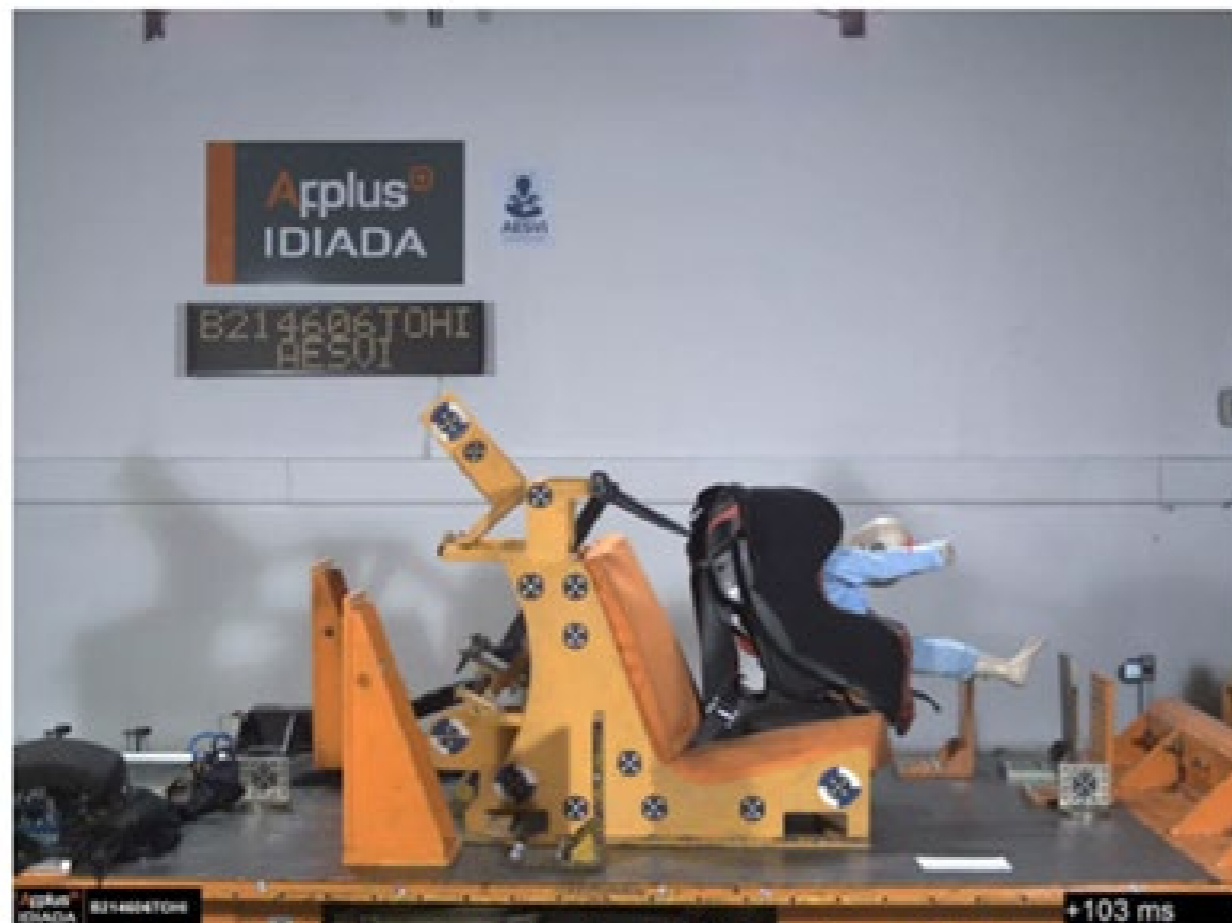
Picture 3: Máximo desplazamiento X / X maximum displacement

Only one of the tests set out in Regulation 44 was sufficient to determine **that 9 out of the 10 CRS randomly purchased on the second hand market would be unable to perform their function** within the limits required by the Regulation.

The general behaviour observed was marked by significant deterioration of the harnesses and their attachments. As a consequence, the retention efficiency of the dummy was drastically reduced, dangerously increasing dummy's excursion, which in some cases exceeded 150 mm the X-axis limits (horizontal displacement).
